Operating Experience Weekly Summary 99-10

March 5 - March 11, 1999

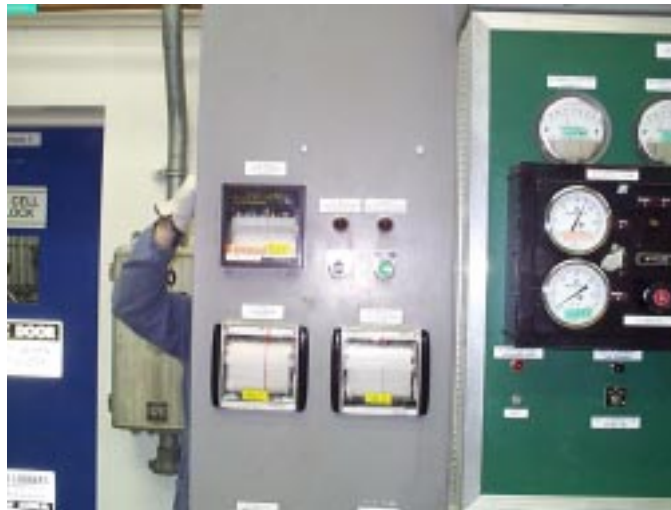
Figure 1-1. Front of Panel

On February 25, 1999, at the Hanford Waste Encapsulation and Storage Facility, an operator received an electrical shock while removing a sticker from the inside of an electrical panel. He was shocked when he touched the contacts of an energized, 120-V indicator light. Physicians evaluated the operator and determined that he could return to work without restrictions. The operator was not qualified to work near exposed, energized circuits and could have been seriously injured. (ORPS Report RL--PHMC-WESF-1999-0005)

The shock caused the operator to involuntarily grasp the energized fixture, but he was able to push himself free. Investigators verified that there were exposed, energized 110-V connectors on the back of the panel and ordered workers to place a nonconductive plastic sheet over the exposed circuits. They determined that the exposed electrical terminals had been allowed by OSHA because they were guarded by an enclosure that was intended to be accessed only by qualified persons. They further determined that the operator had recently completed medium-risk electrical worker training but that this training did not qualify him to gain access to the inside of the energized electrical panel. Investigators determined that if the operator was qualified, he would have recognized the hazard of open electrical terminals and assumed them to be energized until they were verified as being de-energized and locked and tagged out of service. No one attempted to place a lockout/tagout on the energized circuits or perform a zero-energy check. Figure 1-1 shows the front of the panel and Figure 1-2 shows the rear of the panel, the sticker, and the exposed terminals.
